Fourth Five-Year Review Report

FMC Corporation Yakima

Superfund Site

SEPTEMBER 2013

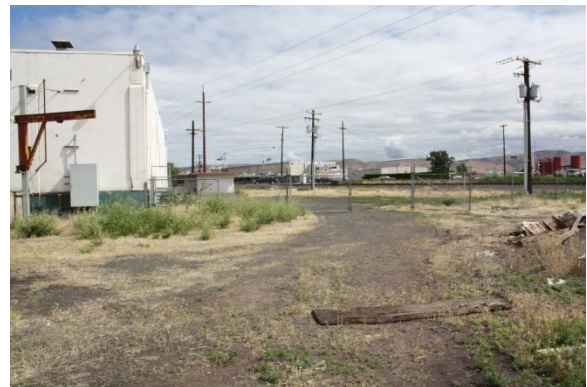
Looking north from the yard at the Stephens Metal Products property. Plume is underneath the location where the photograph was taken and the former pit area is between that position and the warehouse visible in the photograph.

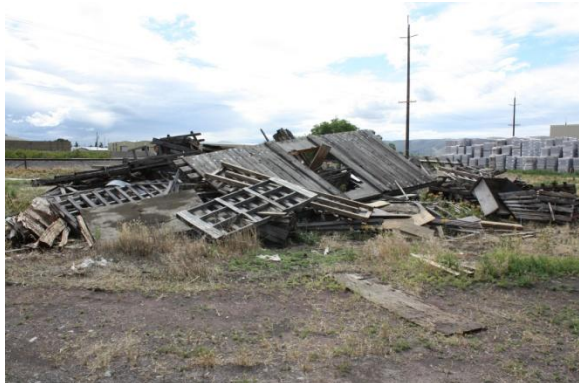
B. Other Site Conditions			
Remarks <u>There was a large pile of debris in the backyard of the Stephens Metal Products owned property. However, it was not in the way of any monitoring wells. Also, some soil was brought in to regrade a portion of the southern border of the Stephens Metals property to make it more level and attractive to a</u>			
VII. LANDFILL COVERS		Applicable	<u>N/A</u> lessee,

Pile of debris in the yard of the Stephens Metal Products property.

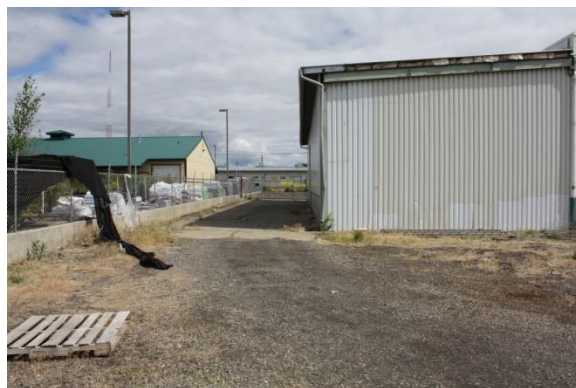
Area between the TrueValue store location and Stephens Metal Products warehouse. Plantings at the store are kept in large above ground planter boxes that are on top of asphalt.

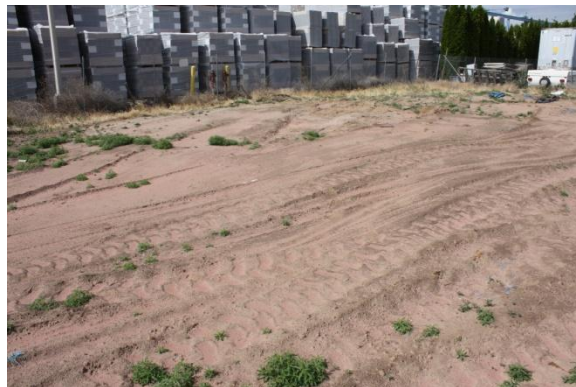
Soil brought in to help grade back part of Stephens Metal Products yard. One of the monitoring wells needed to be uncovered for the fall sampling campaign because it was buried under a couple feet of this material.

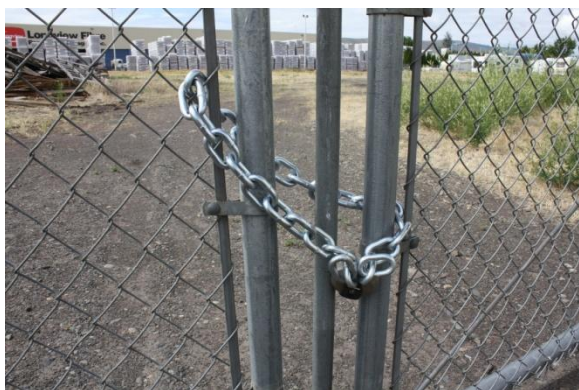
Locked gate at Stephens Metal Products property. Longview Fibre facility is visible in distance.

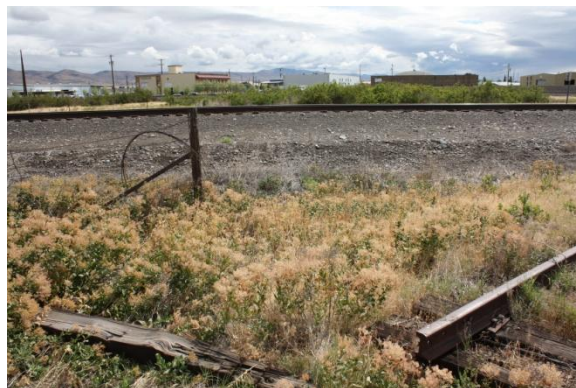
1. ☒ Fencing damaged Location shown on site map ☒ Gates secured N/A
 Remarks No unlocked route for driving onto property.
 However, could access on foot because fence along

Fence down along railroad track (eastern border of the Stephens Metal Products yard).
